<div> <div> <div>LX</div> </div> <div> <div>PART NUMBER</div> <div>SSH-LX5090</div> </div> </div>		<div> <div>REV.</div> <div>A</div> </div>
<div> <div>REV.</div> <div>A</div> </div>	<div> <div>E.C.N. NUMBER AND REVISION COMMENTS</div> <div>E.C.N. #10BRDR. & MODELED.</div> </div>	<div> <div>DATE</div> <div>6-11-99</div> </div>

T-5mm PANEL INDICATOR, 2 PC. HOLDER.

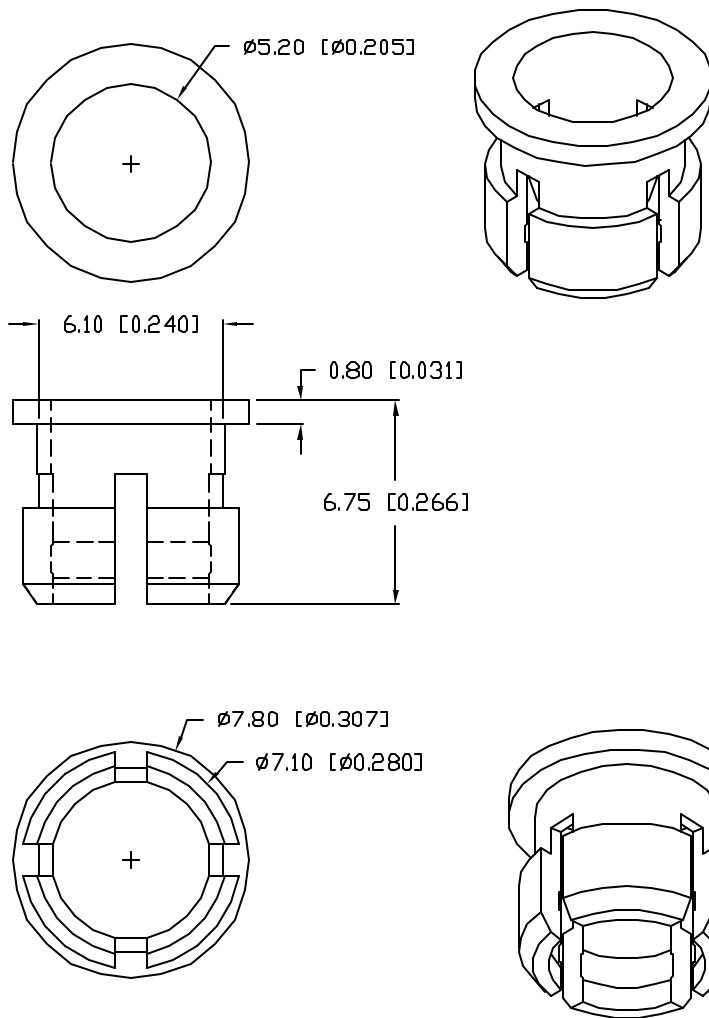
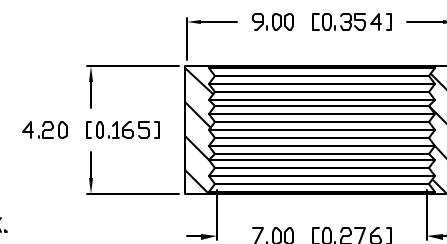
1. MATERIAL: POLYPROPYLENE (PP), BLACK.

*UNLESS OTHERWISE SPECIFIED TOLERANCE IS $\pm 0.25\text{mm}$ ($\pm 0.010"$)
